PROPERTY INSPECTION REPORT

1212 S 12th St, Tacoma, WA, 98465

Date of Inspection: 10/30/2023

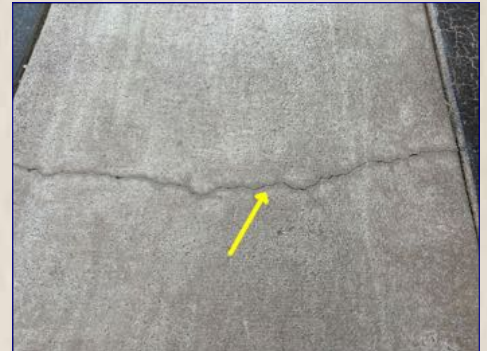
The Service Walk View

The walkway had some typical cracking/chipping but is usable. Sealing of the cracks by a licensed contractor to help prevent additional damage is recommended.

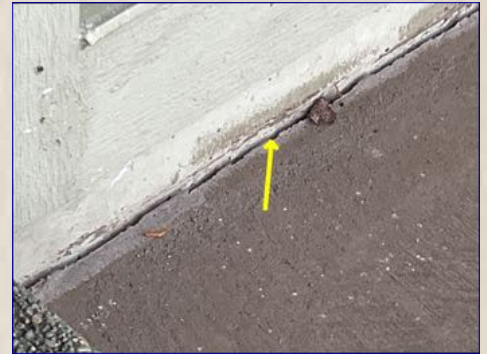
The Porch View

There was a gap between the porch and the home. A licensed contractor should seal the gap between porch and home to help prevent moisture damage.

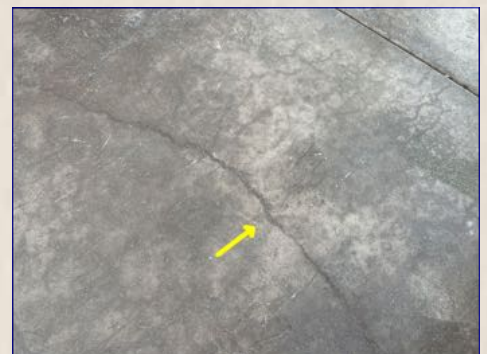
The Patio View

The patio had typical cracks. Sealing of the cracks to help protect the cement from damage is recommended.

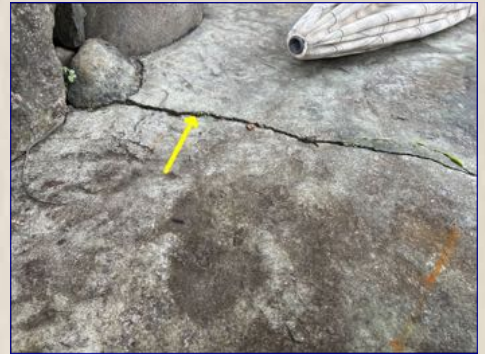
The Patio View

The patio had some settling cracks, which presents a tripping hazard. It is recommended that a licensed contractor repair or replace.

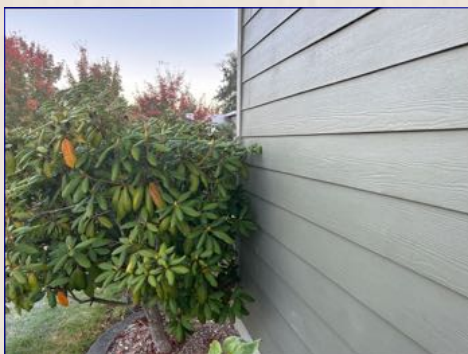
There was vegetation in contact with the house. Recommend trimming trees/vegetation, so that it doesn't come into contact with the home.

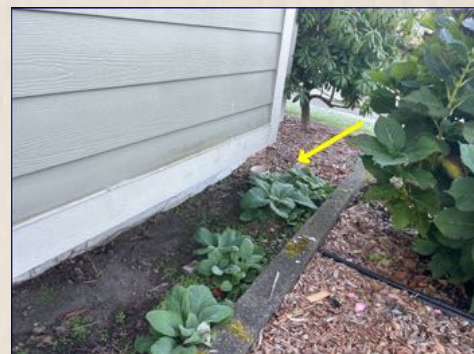
There was a negative grading slope, toward the foundation, in one or more locations. Recommend maintaining a positive drainage slope away from the foundation. Consult a professional landscaper for proper drainage and grading as needed.

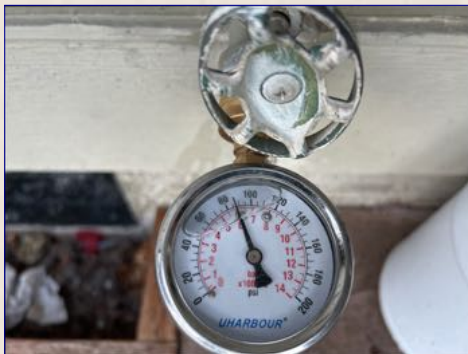
The water pressure in the house as measured at the hose bib is greater than 80 psi, which will create additional wear and tear on the plumbing fittings and household appliances. Repair by a licensed plumbing contractor is recommended.

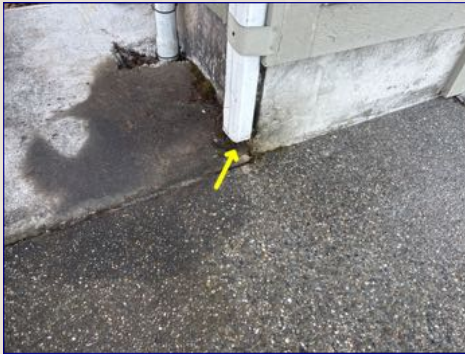
The gutter downspouts don't direct water far enough away from the house. Recommend adding downspout extensions (5-6' extensions recommended) to discharge away from the home.

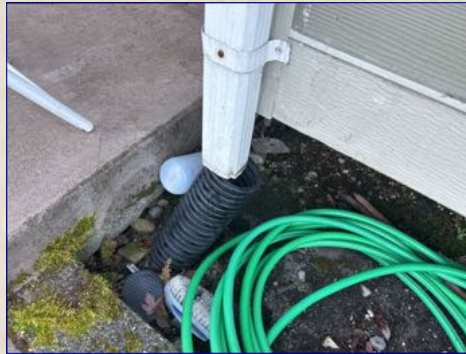
The downspout was not securely connected to the drain line, which will allow water to discharge next to the foundation. Repair by a qualified professional is recommended.

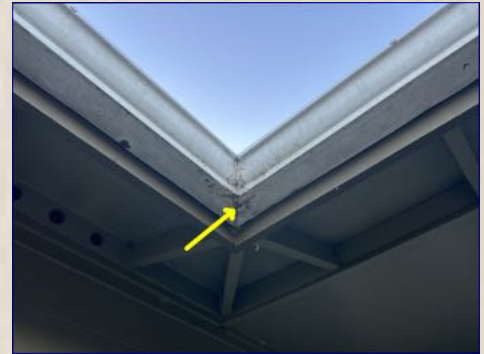
There is evidence that the gutter is leaking at the seams. Recommend a professional contractor evaluate and repair as needed.

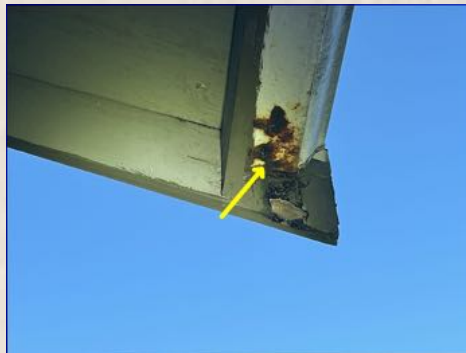
There is evidence that the gutter is leaking at the seams. Recommend a professional contractor evaluate and repair as needed.

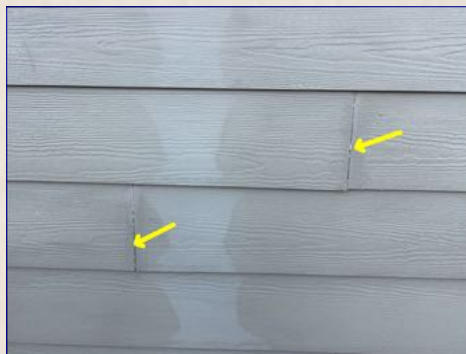
Flashing was not installed at the butt joints of the siding, this may allow water to flow behind the siding and into the wall cavity. The wrap behind the siding is a vapor barrier and is not waterproof. Installation of proper flashing by a licensed contractor is recommended.

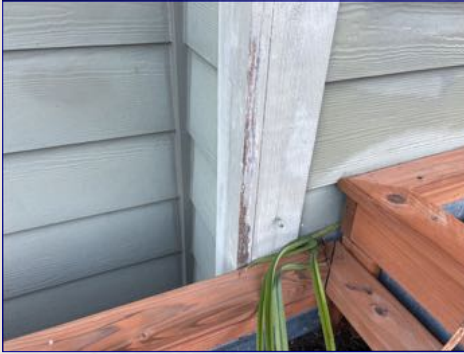
The exterior trim was in need of normal painting maintenance. Recommend a professional painter repair/paint the exterior trim.

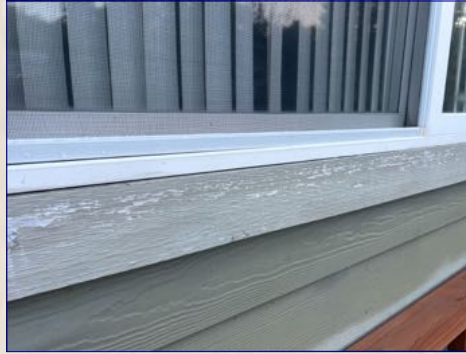
The exterior trim was in need of normal painting maintenance. Recommend a professional painter repair/paint the exterior trim.

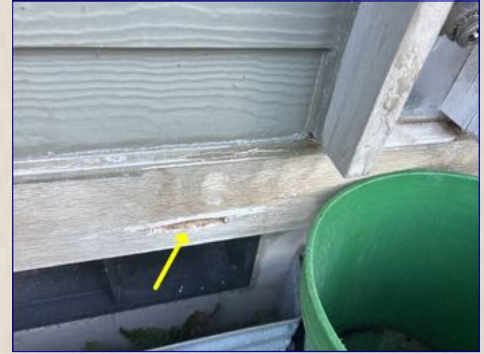
Some of the trim was damaged. Recommend repair or replacement of damaged exterior trim by a licensed contractor.

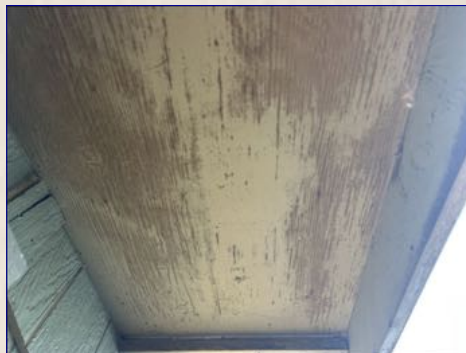
The soffit needed routine painting maintenance. Recommend a professional painter repair/paint as needed.

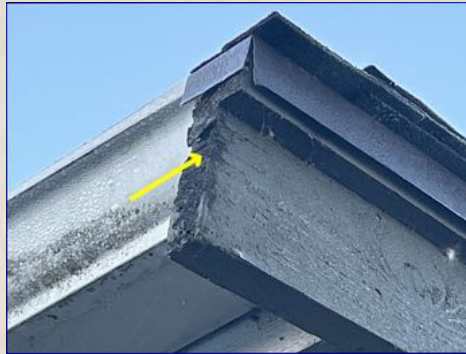
The fascia is damaged at the ends in more than one location. Recommend the damaged sections be replaced/repaired by a licensed contractor.

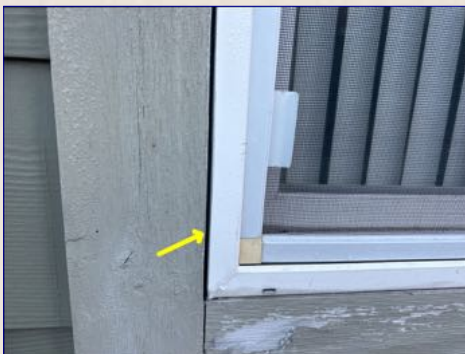
Recommend caulking around windows, doors, corners, and utility penetrations to prevent moisture and pest intrusion.

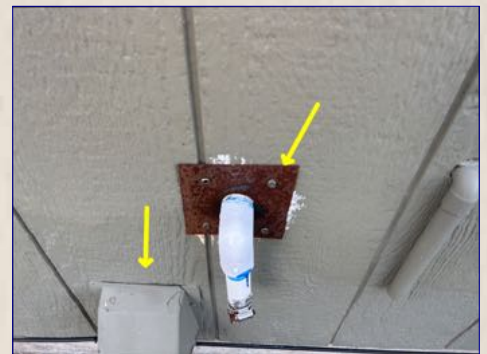
Recommend caulking around windows, doors, corners, and utility penetrations to prevent moisture and pest intrusion.

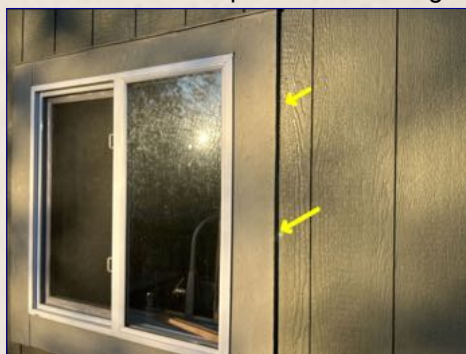
The caulking is dried and cracked. Recommend a professional contractor to remove and replace the caulking.

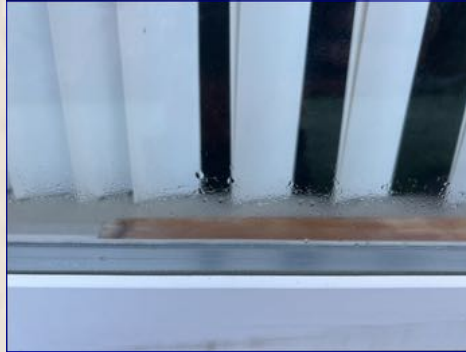
There is evidence of damaged insulated glass at the primary bedroom window, which will make the windows less efficient, and the seal will fail over time. Replacement of the damaged panel is recommended.

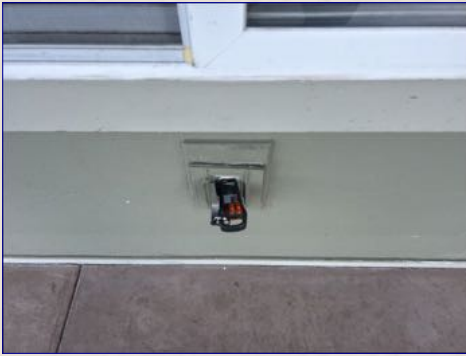
GFCI receptacles are not installed at outdoor locations, which is a safety concern. Recommend a licensed electrician install GFCI receptacles.

There are loose receptacles on the house exterior. This is a safety concern. Recommend a licensed electrician repair.

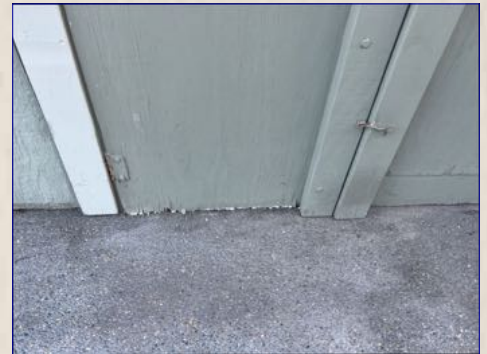
The shed door was water damaged. Repair or replacement is recommended.

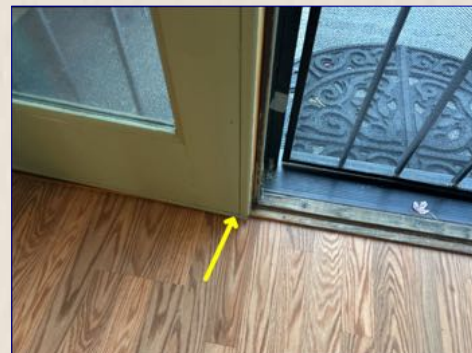
The patio door was rubbing on the door sill, making it difficult to open and close. Recommend having a qualified contractor adjust the door for proper closure.

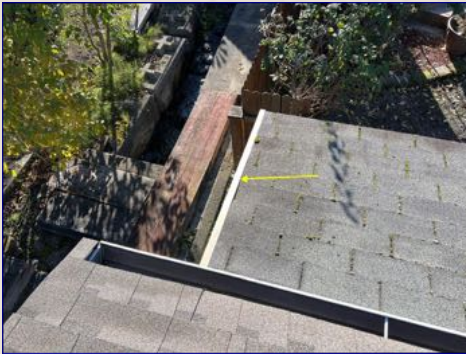
The flashing on the roof of the shed was improperly installed, which is evidenced by water damage to the soffit and roof sheathing. Repair by a licensed roofing contractor is recommended.

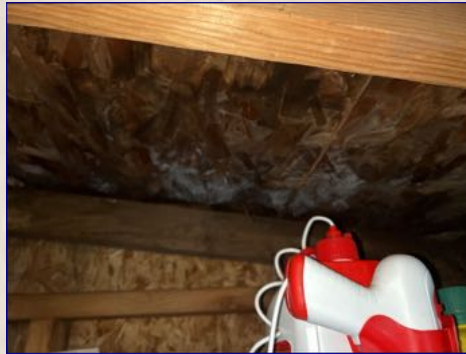
The flashing on the roof of the shed was improperly installed, which is evidenced by water damage to the soffit and roof sheathing. Repair by a licensed roofing contractor is recommended.

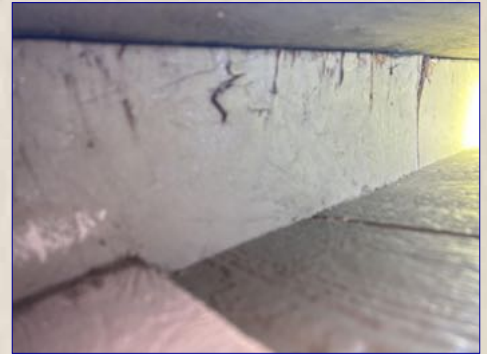
The flashing on the roof of the shed was improperly installed, which is evidenced by water damage to the soffit and roof sheathing. Repair by a licensed roofing contractor is recommended.

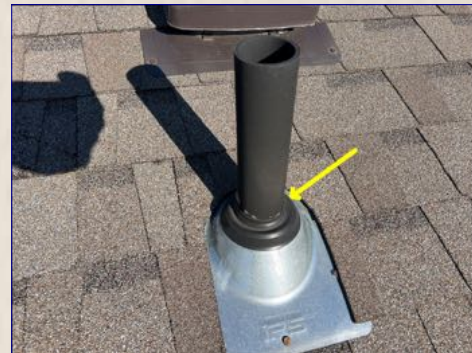
The Plumbing Vent(s)

One or more plumbing vent flashing was sunken, which can allow water/ice build-up and cause premature failure and leaking of the plumbing vent. Recommend a professional roofing contractor repair or replace the roof pipe flashing.

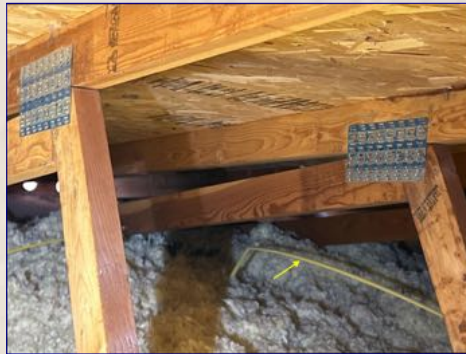
There is Romex wiring not properly secured in the attic at more than one location, which is a safety concern. A licensed electrician should be consulted to repair.

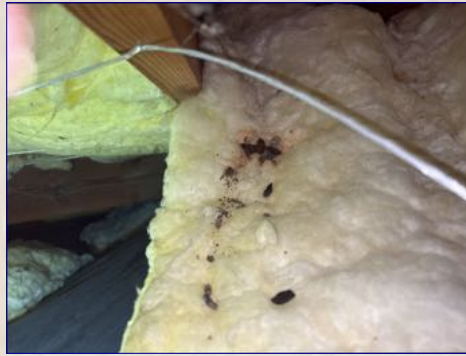
Pests are not part of the home inspection. However, there is evidence of rodent feces in the crawlspace, which is a safety concern. Recommend a professional exterminator be consulted.

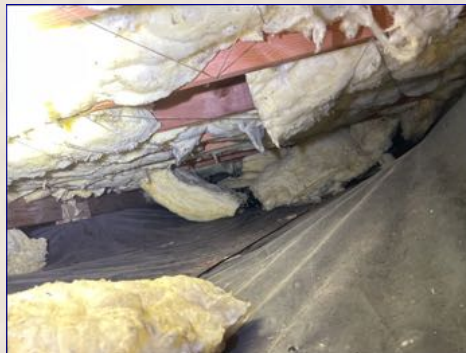
There was fallen insulation at more than one location in the crawlspace. Repair by a qualified contractor is recommended.

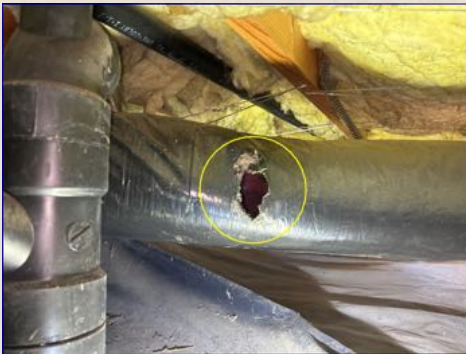
The Flexible ducting was damaged at more than one location. To improve HVAC efficiency, repair/replacement by a licensed HVAC contractor is recommended.

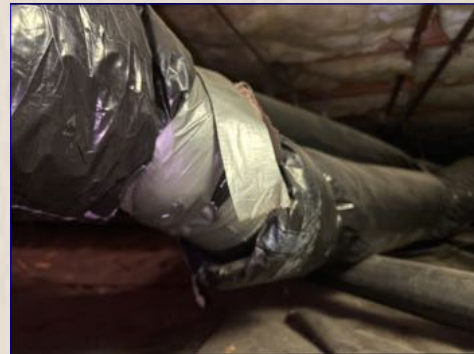
The Flexible ducting was damaged at more than one location. To improve HVAC efficiency, repair/replacement by a licensed HVAC contractor is recommended.

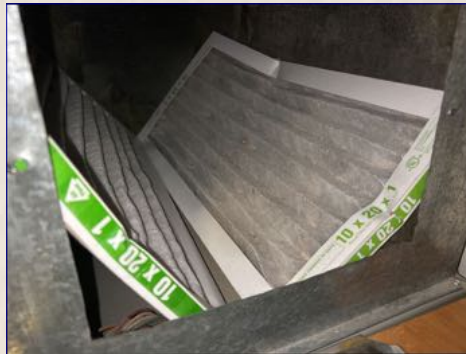
The furnace had improperly sized filters installed. Installation of properly sized filters is recommended. Consult a licensed HVAC contractor as needed.

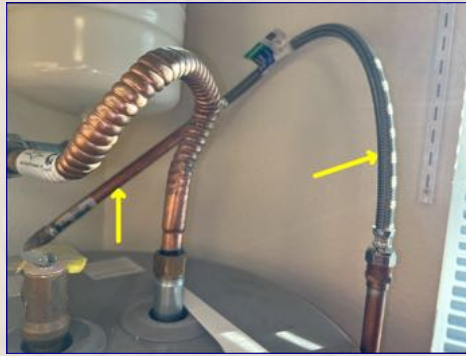
The temperature Pressure Relief valve (TPRV)

The temperature-pressure relief valve extension was improperly sized on the water heater. The plumbing should not reduce in size from where it connects to the TPRV. Correction by a licensed plumber is recommended.

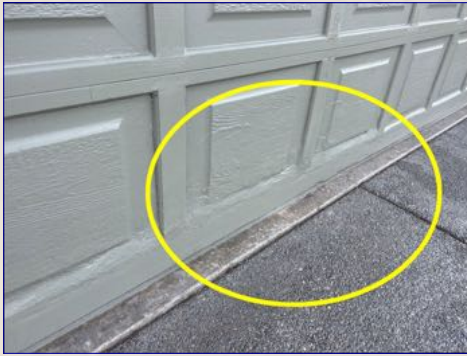
The lower panel of the overhead door had significant water damage. Replacement of the panel by a qualified professional is recommended.

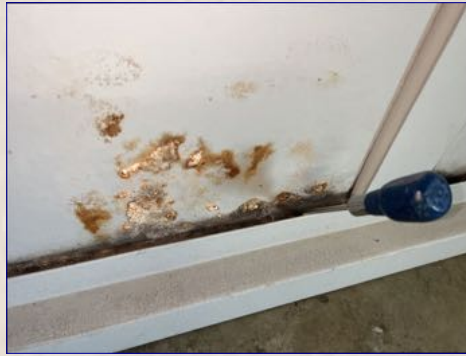
The lower panel of the overhead door had significant water damage. Replacement of the panel by a qualified professional is recommended.

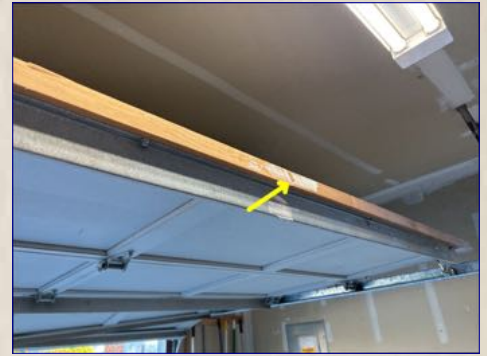
Recommend painting the outside edges to help prevent water damage.

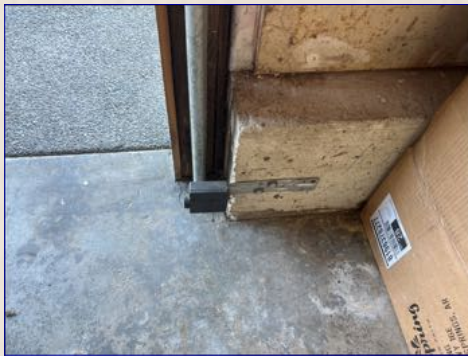
The electric eyes on the garage door opener had been bypassed. This is a safety hazard. Repair by a qualified professional is recommended.

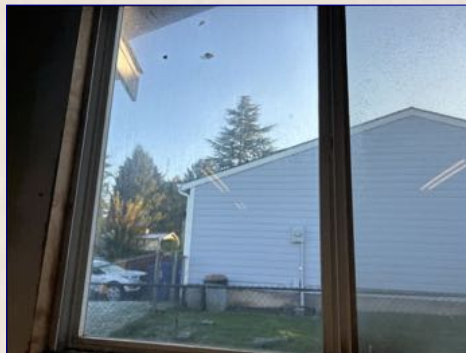
The window was difficult to open. Repair by a qualified professional is recommended.

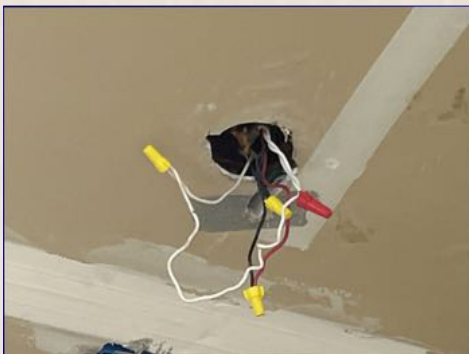
There are spliced wires that are not enclosed in junction boxes in the garage. This is a safety hazard. Recommend a licensed electrician repair.

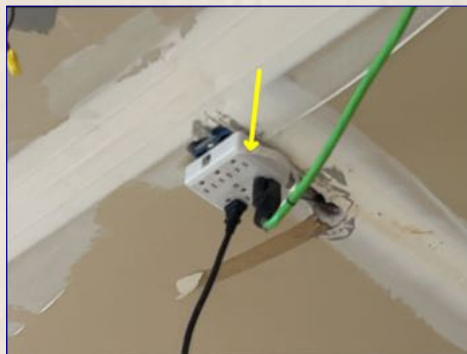
Multi-tap electrical receptacle present in the garage. Multi-tap receptacles can cause an overloaded circuit and possible damage. Safety concern. Recommend a licensed electrician evaluate and repair.

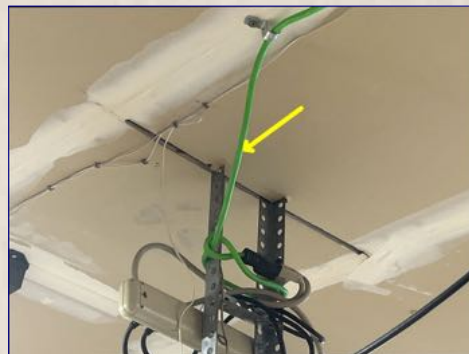
Extension cord wiring exists in the garage. Extension cords should never be used as permanent wiring. Recommend a licensed electrician repair.

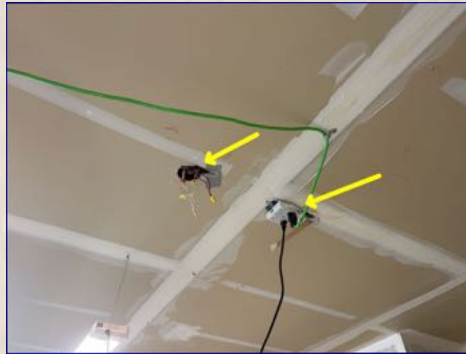
The fire separation wall was damaged between the garage and the living area of the house. This is a safety hazard. Recommend a licensed contractor repair.

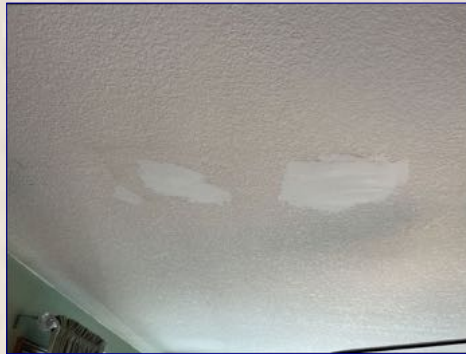
There were unprofessional repairs to the ceiling in the kitchen area. A professional painter should repair and paint as needed.

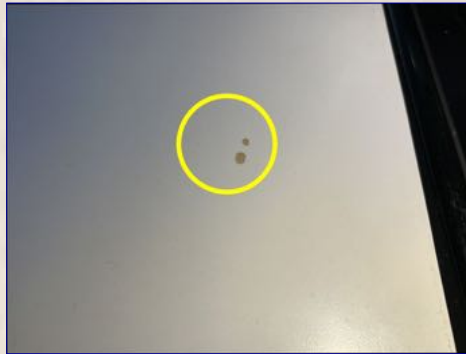
The counter top was damaged in one or more areas. Recommend a professional contractor repair or replace as needed.

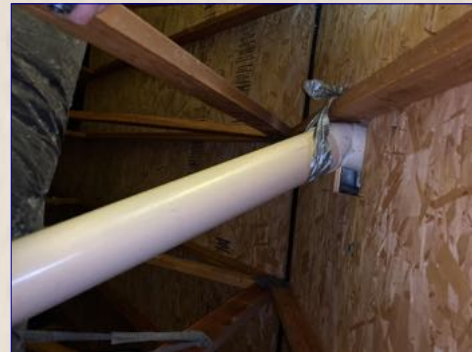
There was a vent connected to the register on the ceiling in the utility room. This may have been a fresh air supply for a previously installed LP appliance. Removal of the piping and repair of the ceiling by a licensed contractor is recommended.

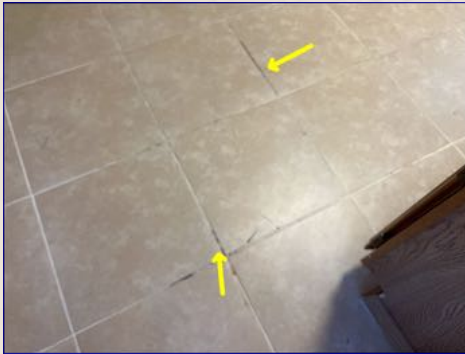
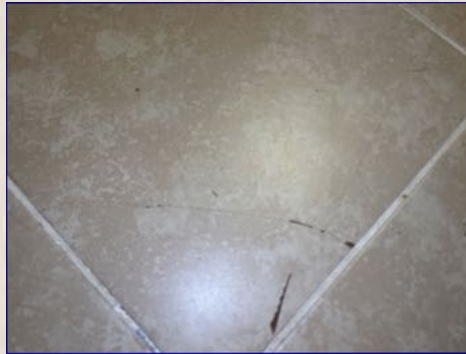
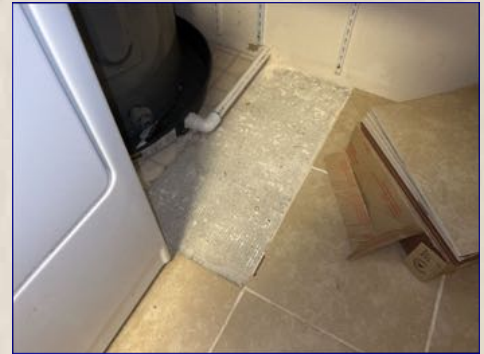
The floor was missing tiles, had cracked tiles and was missing grout. Repair by a licensed contractor is recommended.

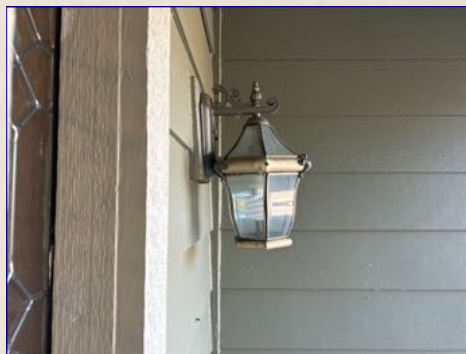
The light doesn't operate when the porch light switch is engaged. Recommend changing the bulb(s) and re-testing. Consult a licensed electrician as needed.

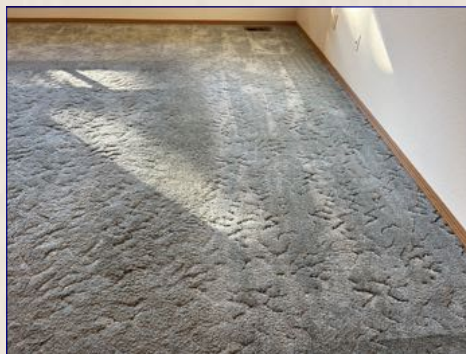
The Carpet was stained. Professional cleaning or replacement is recommended.

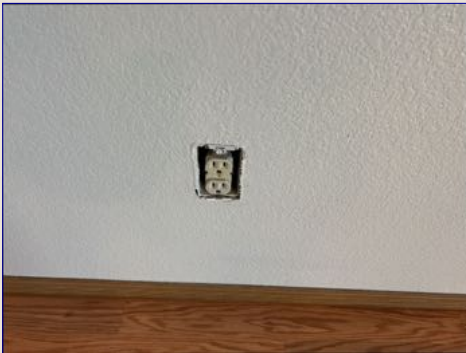
At least one cover plate is missing at a receptacle in the great room, which is a potential safety concern. Recommend installing cover plates.

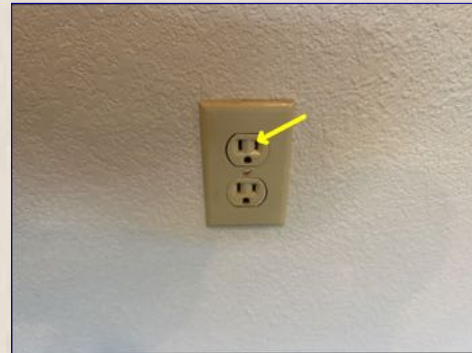
There was an obstruction in the receptacle that prevented the insertion of a plug. Repair by a licensed electrical contractor is recommended.

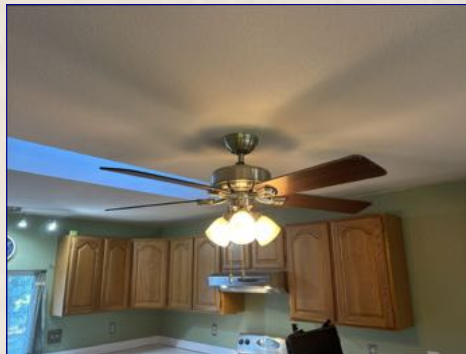
The ceiling fan in the living room was not operational when tested. Recommend a licensed electrician evaluate and repair or replace as needed.

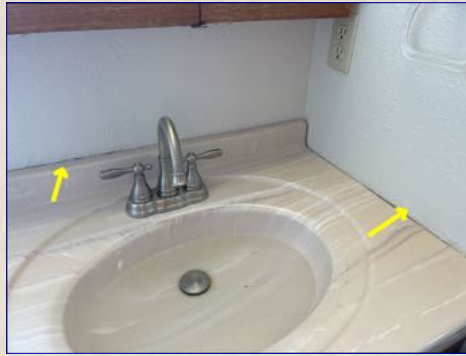
The caulk was missing dried or cracked. Recommend replacing the caulking in the bathroom.

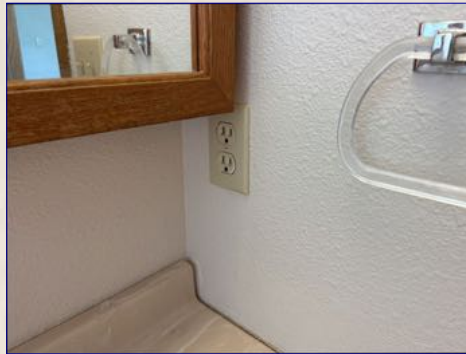
There are loose receptacles present in the bathroom, which is a potential safety concern. Recommend a licensed electrician repair.

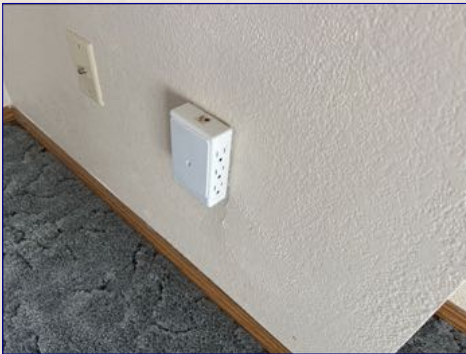
Multi-tap electrical receptacles present in the bedroom. Multi-tap receptacles can cause an overloaded circuit and possible damage, which is a safety concern. Recommend a licensed electrician repair.

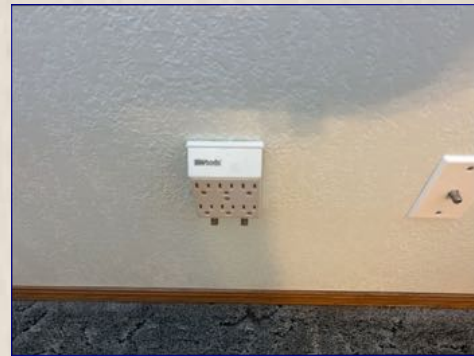
Multi-tap electrical receptacles present in the bedroom. Multi-tap receptacles can cause an overloaded circuit and possible damage, which is a safety concern. Recommend a licensed electrician repair.
