PROPERTY INSPECTION REPORT

1212 S 12th St, Tacoma, WA, 98465

Date of Inspection: 10/30/2023

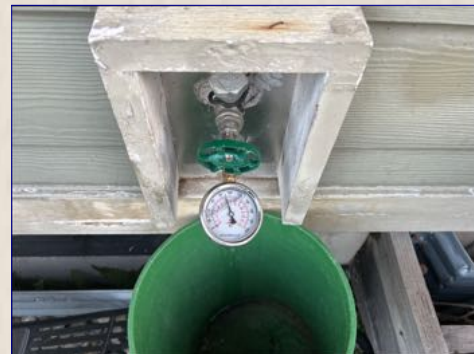
Hose bib operational.

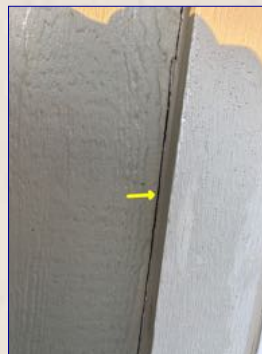
The caulking is dried and cracked. Recommend a professional contractor to remove and replace the caulking.

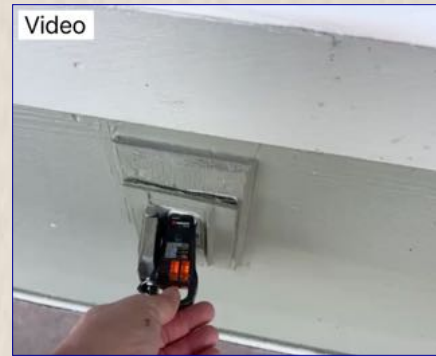
There are loose receptacles on the house exterior. This is a safety concern. Recommend a licensed electrician repair.

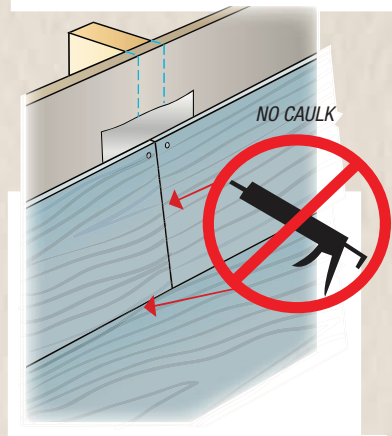
FIGURE 2

James Hardie also DOES NOT recommend applying caulk to the horizontal overlap between siding planks (see Figure 2).

James Hardie does not recommend caulking butt joints or the horizontal overlaps

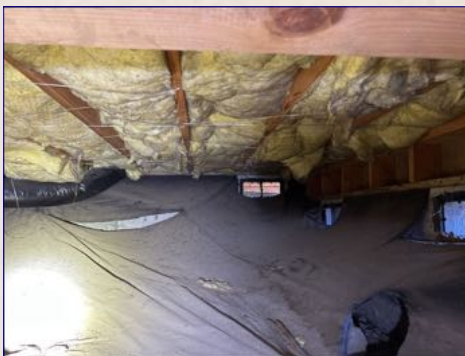
The crawl space

• Pests are not part of the home inspection. However, there is evidence of rodent feces in the crawlspace, which is a safety concern. Recommend a professional exterminator be consulted.

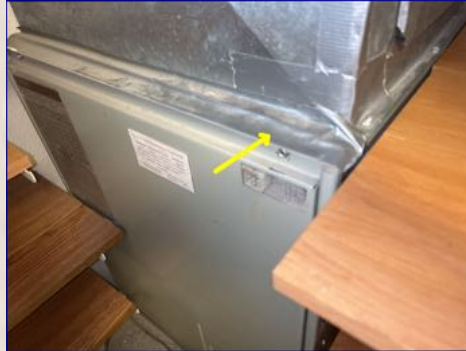
The furnace cover was sealed closed. The interior components could not be evaluated. Consult a licensed HVAC contractor as needed.

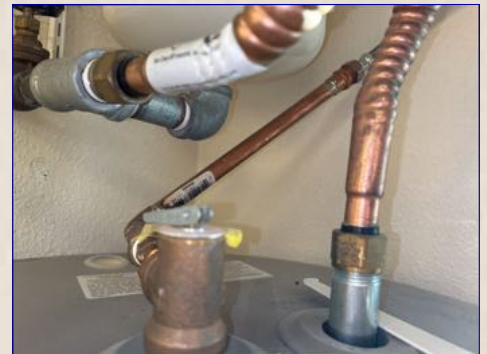
The temperature Pressure Relief valve (TPRV)

- The temperature-pressure relief valve extension was improperly sized on the water heater. The plumbing should not reduce in size from where it connects to the TPRV. Correction by a licensed plumber is recommended.

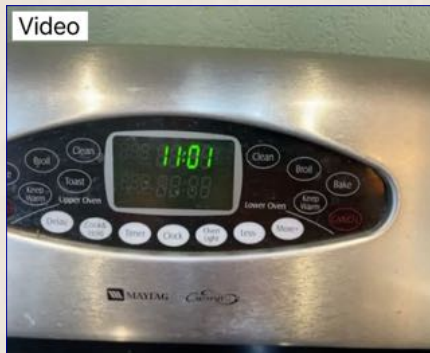
The broiler function was not working. When turned on, an unknown error code flashed on the screen. Evaluation and repair by a qualified professional is recommended.

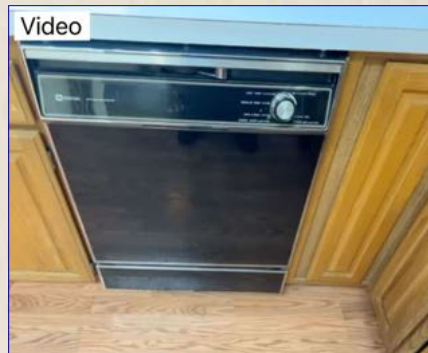
The dishwasher was operable. However, when running it produced an excessive amount of noise. Repair or replacement is recommended.

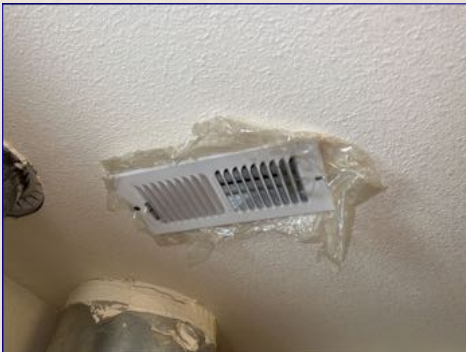
There was a vent connected to the register on the ceiling in the utility room. This may have been a fresh air supply for a previously installed LP appliance. Removal of the piping and repair of the ceiling by a licensed contractor is recommended.

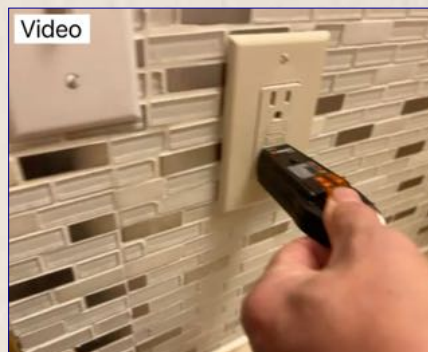
There are loose receptacles present in the bathroom, which is a potential safety concern. Recommend a licensed electrician repair.

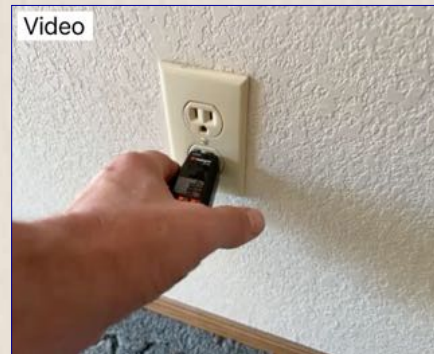
There are loose receptacles present in the bedroom, which is a potential safety concern. Recommend a licensed electrician repair.

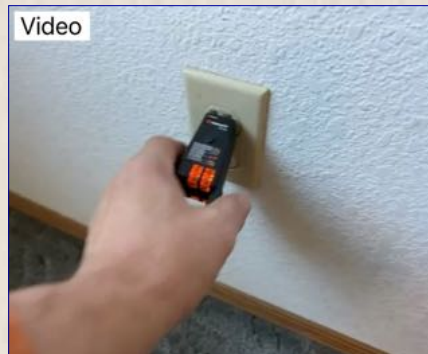
There are loose receptacles present in the bedroom, which is a potential safety concern. Recommend a licensed electrician repair.

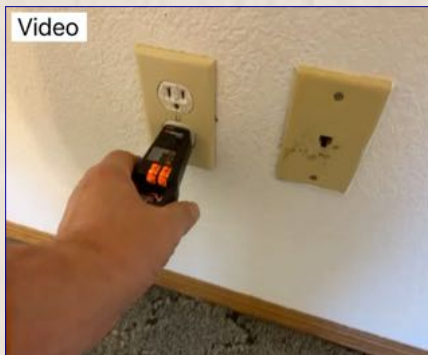
There are loose receptacles present in the bedroom, which is a potential safety concern. Recommend a licensed electrician repair.

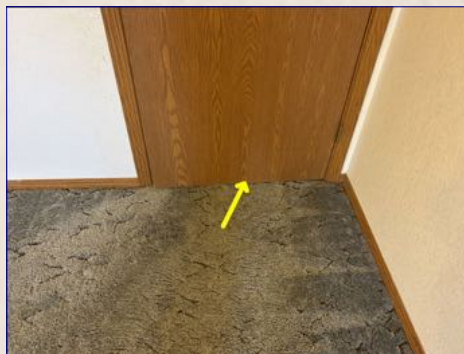
There appeared to be no return air duct on the wall or under the door. This may affect the efficiency of the heating/cooling system in the room. Consult a professional HVAC contractor as needed.

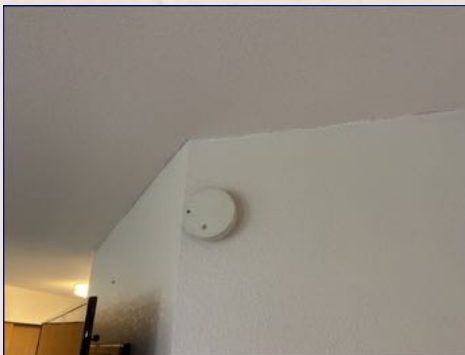
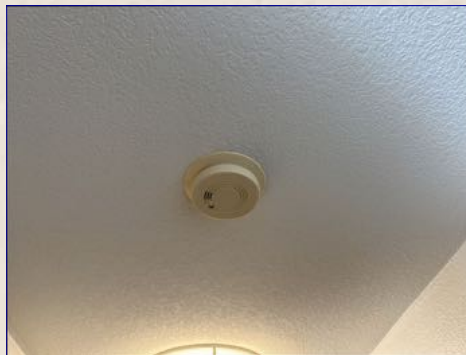
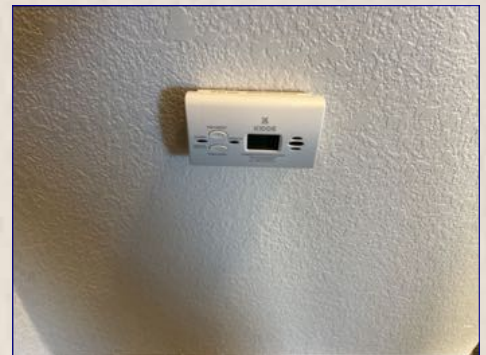
• Not all bedrooms had smoke detectors installed, which is a potential safety concern. It is recommended that smoke detectors be installed in the following locations per the manufacturers instructions:
